Snow and ice belong outside— not in a bakery

▶ **Improper airflows and the buildup of snow and ice on freezer coils, walls and floors waste energy and create extra work.**

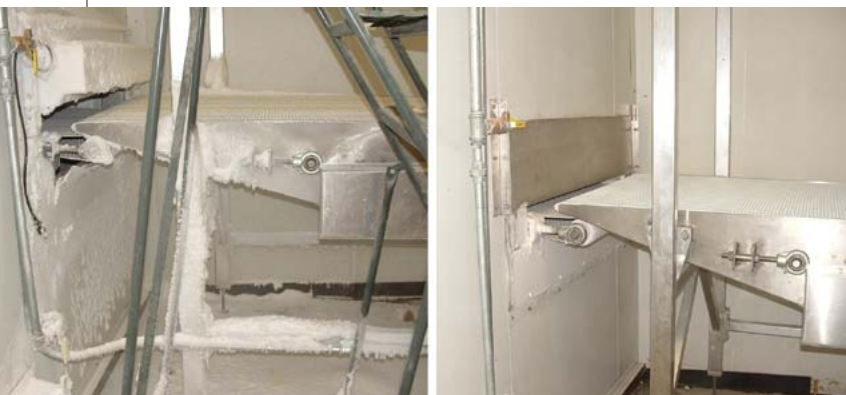
▶ (Left): At Orlando Baking Company, ice and snow built up on freezer coils, the opening to the freezer, the floor and the equipment. (Right): After installing IJ White’s Auto Pressurization System and establishing proper airflow, the ice and snow problems vanished from equipment and the freezer space. Source: IJ White.

But the bakery was experiencing serious problems with warm, moist air entering its blast freezing systems. The moist air was entering the spiral freezer openings, and the moisture was freezing on the refrigeration coils, creating frost and ice. Within a few hours of starting production, the blast freezer had difficulty maintaining freezing temperatures.

In addition, snow was accumulating on the freezer floor and around the openings, which needed to be cleaned on a regular basis. Also, ice and snow were building up on the outside of the openings of the blast freezing rooms. When the openings were exposed to

IJ White sent its design engineers to review the situation and found the problem was even more difficult because there were two independent spiral freezers in one room, which meant there were four openings that needed to be controlled. IJ White’s engineering group was able to apply its pressurization technology, dramatically minimizing the amount of warm, moist air that enters the blast freezer. In addition, the amount of freezing-cold air exiting the lower conveyor openings was also reduced.
